Appendix A

Site Visit Summaries

30 June 2015 FINAL DRAFT

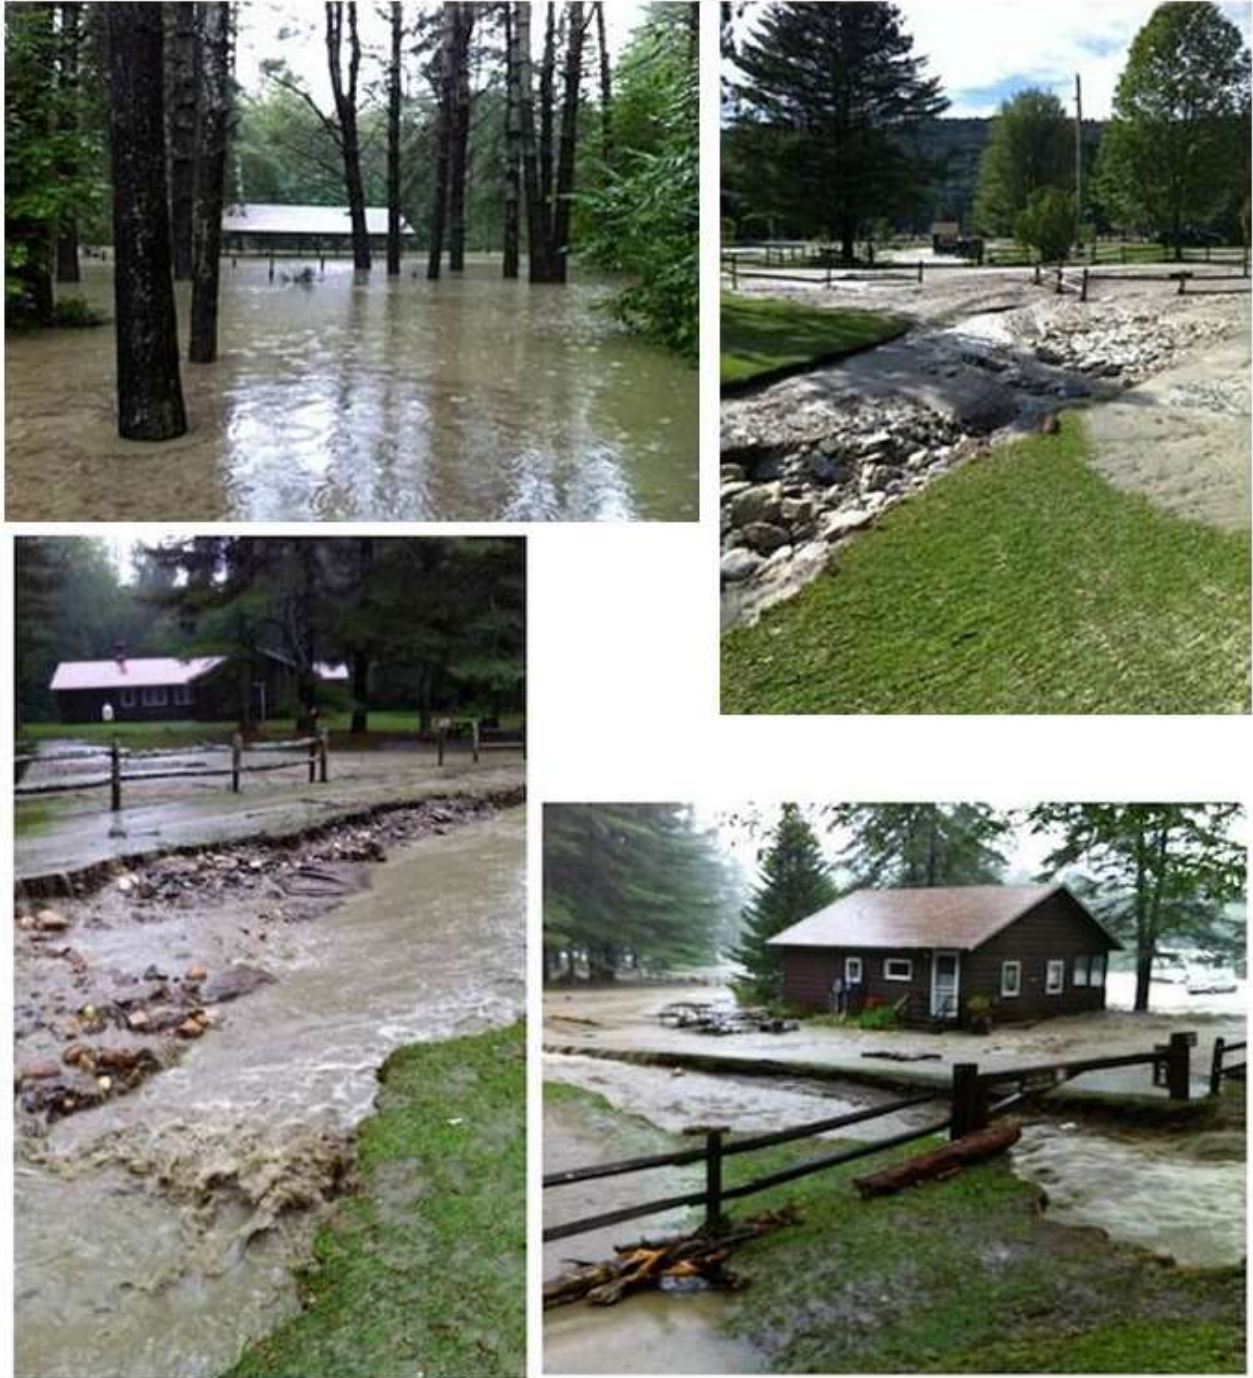
Camp Plymouth State Park at the mouth of Buffalo Brook sustained substantial damages during Tropical Storm Irene (Figure 3). More than 35,000 yards of silt, sand and gravel were excavated from the park in the months following the flood [4]. Dredging of silt from the beach area in Echo Lake also occurred following TS Irene.

Figure 3. Camp Plymouth State Park in the hours and days following TS Irene. Photo credits: Chris Saylor. Source: Vermont State Parks after Irene, 8/22/12, Vermont Public Radio <http://www.vpr.net/episode/54251/slayton-vermont-state-parks-after-irene/>

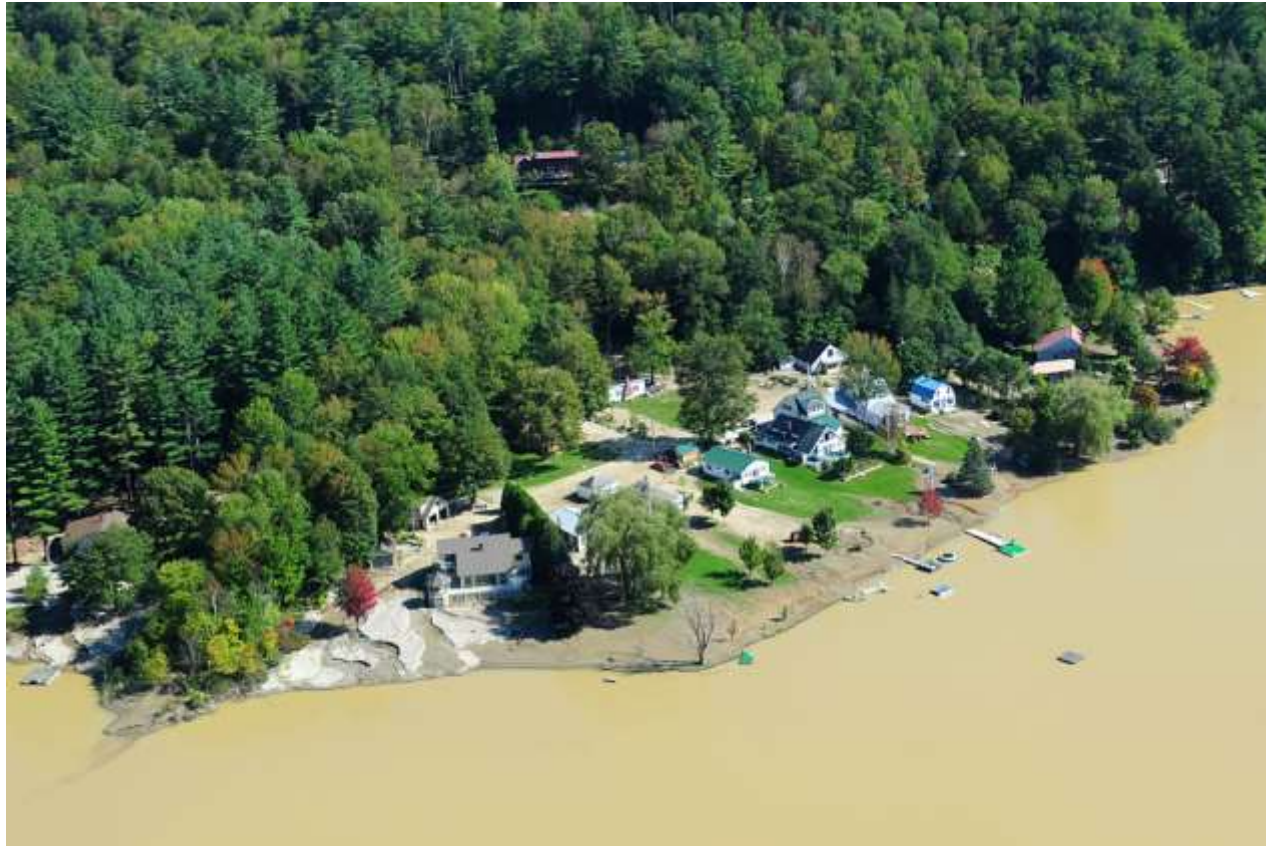
Echo Lake was highly turbid in the weeks following TS Irene (Figure 4). Water clarity issues persisted for months, in part due to channel activities associated with road and other infrastructure repairs in upstream reaches of the Black River [6].

Figure 4. Aerial view of Echo Lake just south of Camp Plymouth State Park, in the vicinity of the Kingdom Brook confluence, view to the southeast, 12 September 2011.

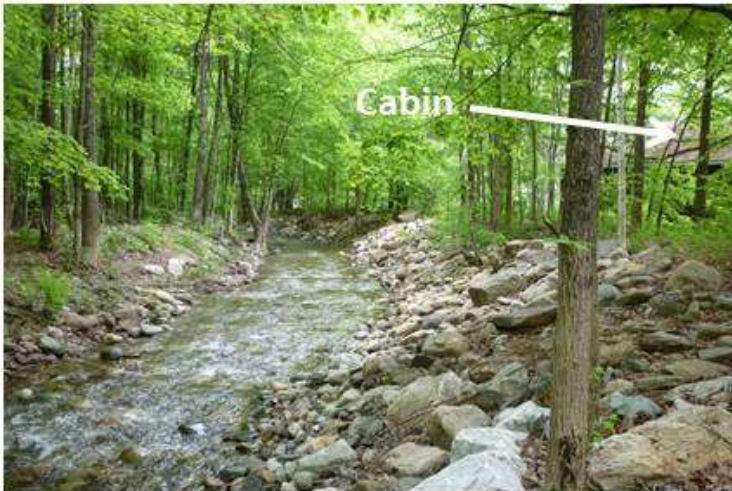
3. View downstream in Buffalo Bk adjacent to Park cabins.

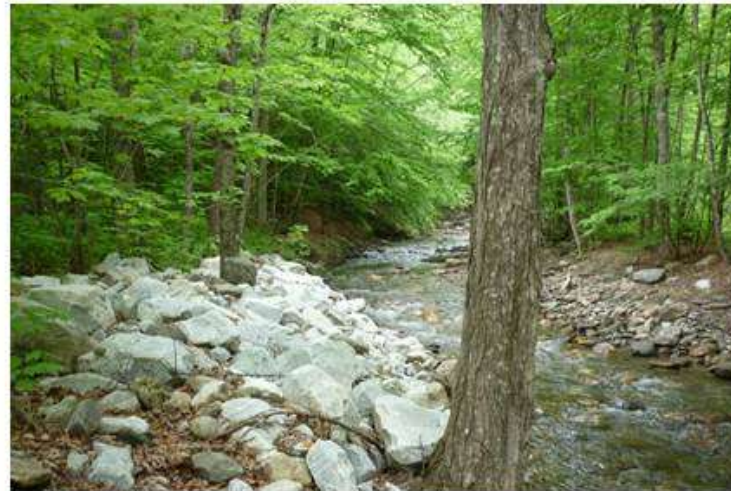
4. View upstream from cabins; post-Irene streambank armor.

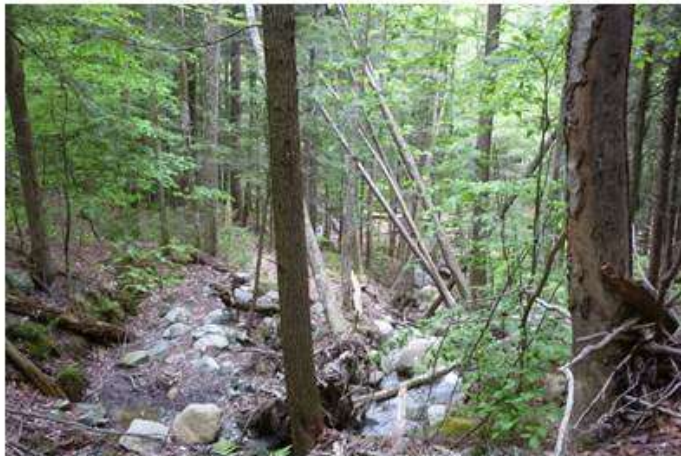
7. Incision and widening of stream channel observed downslope from C2 forest road crossing.

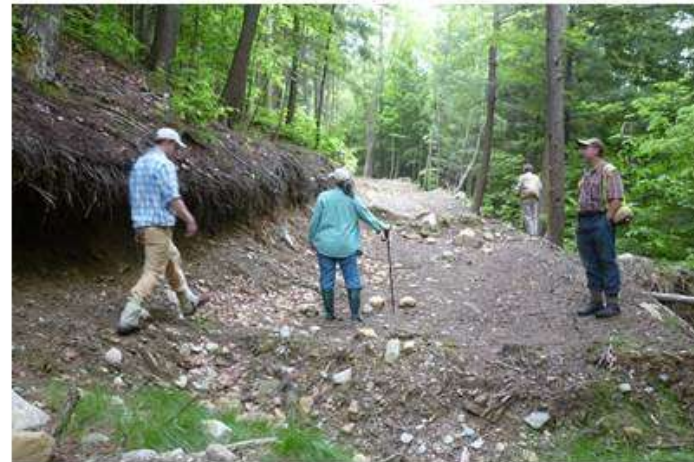
- Several segments of the new trail exceed 10% gradient and traverse very steep slopes (photos 6, 8).

8. Forest road installed across >35% slopes, to access patch cuts. Steepness of hillsides and use of skidders necessitated wide road cuts. Steepness of road grade (>10%) required frequent water bars.

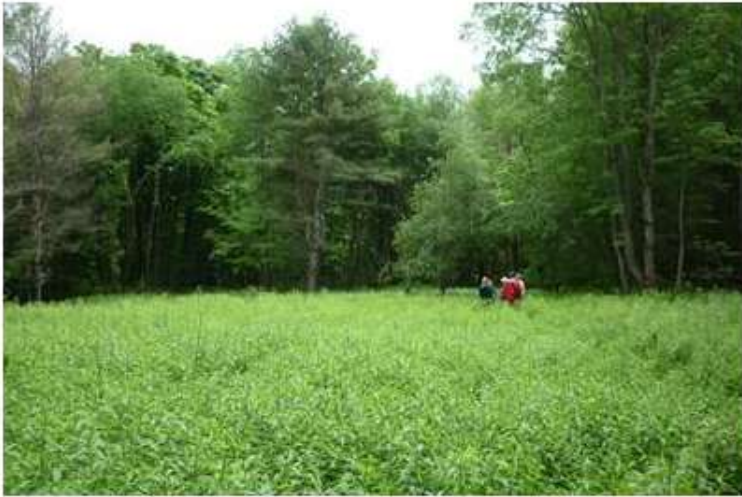
1. View to east to log landing last worked in 2013; accessed from western-boundary parking area off N End Rd.

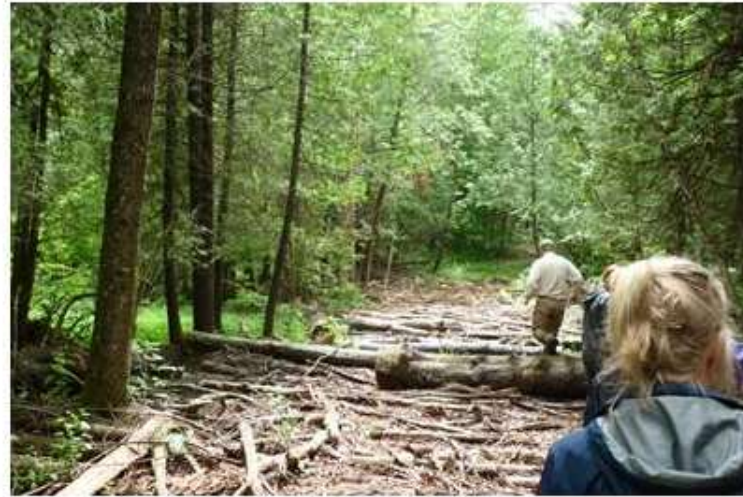
2. Stream crossing stabilized with coarse woody debris.

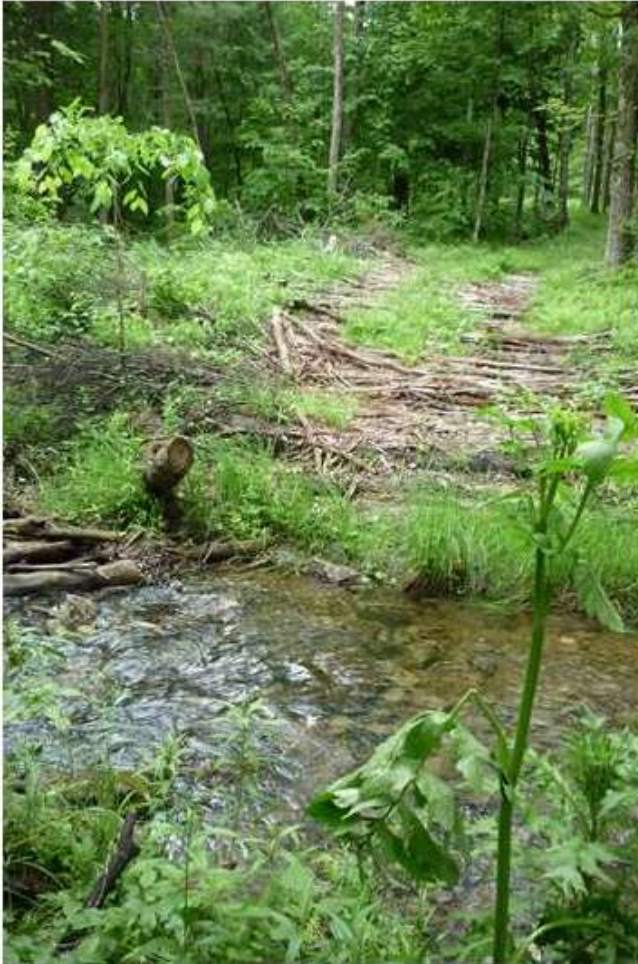
- Exemplary practices were observed including coarse woody debris corduroy at stream crossings. This site prompted a discussion of the value of river corridors (per VANR guidance) over simple setbacks defined in AMPs.

5. Exemplary stream crossing practice.

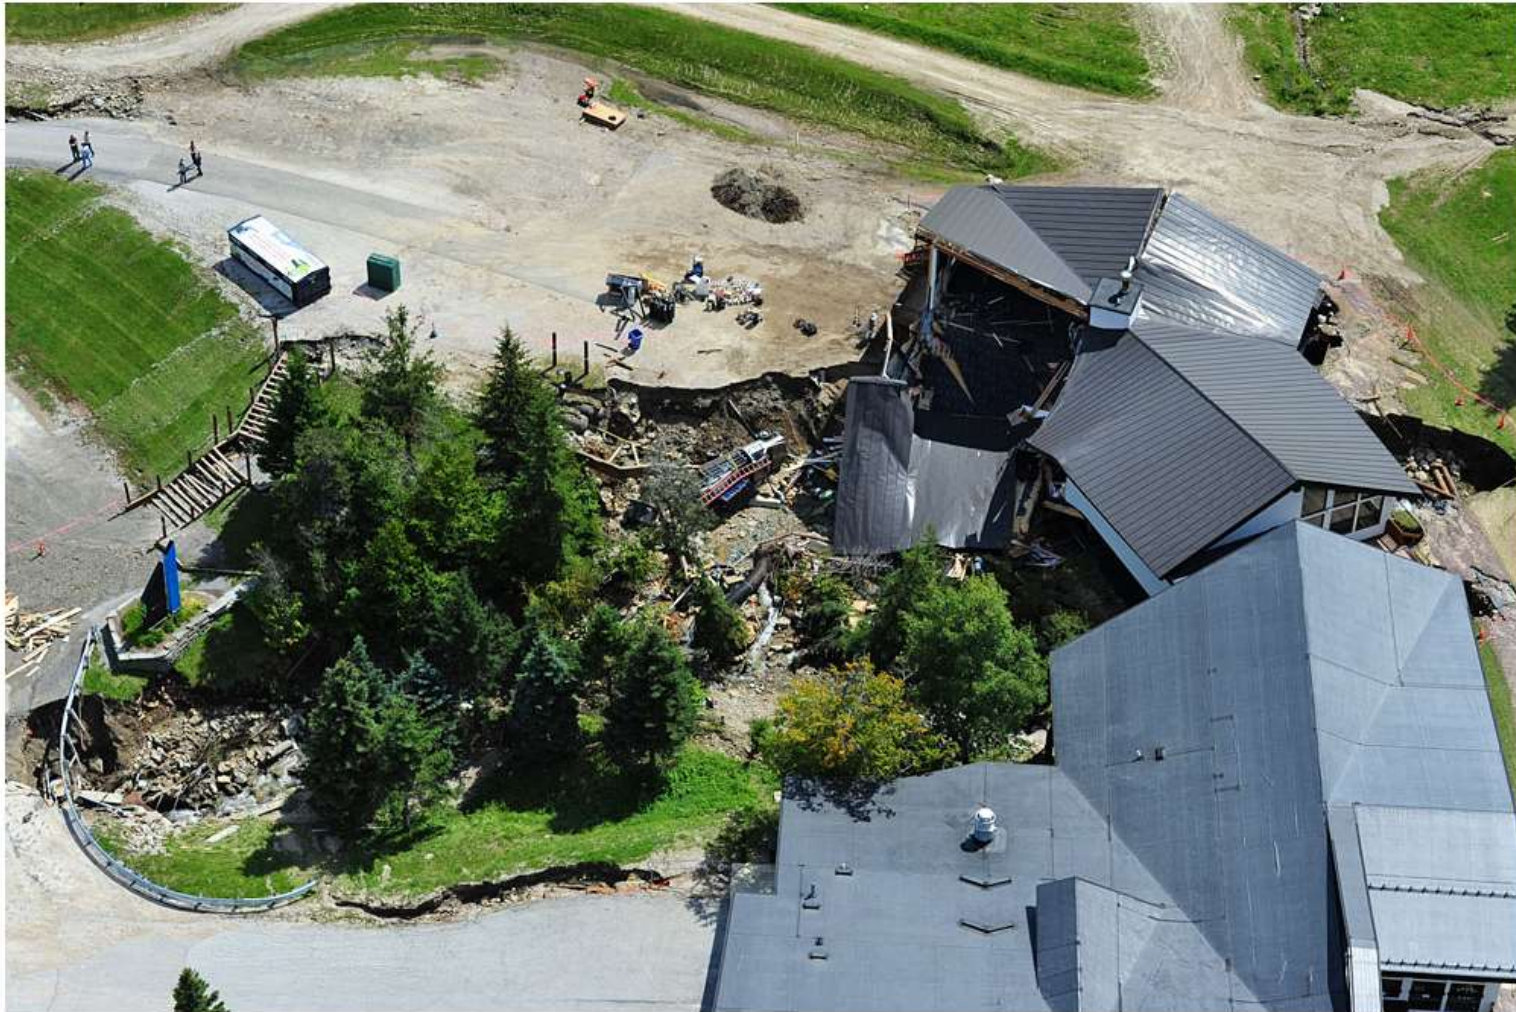
Killington Resort sustained \$6.2 Million damage during TS Irene (28-29 August 2011). Insurance covered buildings, but not trail damages [4]. Floodwaters of the Roaring Brook undermined the foundation of the Superstar Pub, an addition to the K-1 Lodge which had been built over the brook (see Photo 1). At this location the Roaring Brook is a second-order stream with an upstream drainage area of only 0.67 square mile. Based on peak flow measured at the nearby Kent Brook gage, the peak flow in Roaring Brook at this location during TS Irene would have been approximately 575 cubic feet per second. At a gradient of 8%, this discharge would have been sufficient to generate bed shear stresses well in excess of 20 pounds per square foot. The pub was rebuilt, but as a separate structure located to the east of the

Photo 1. Partial collapse of K-1 base lodge, Superstar Pub addition, at Killington Resort – August 31, 2011. Building foundation and access road undermined by floodwaters from the Roaring Branch. Photo Credit: Lars Gange and Mansfield Heliflight

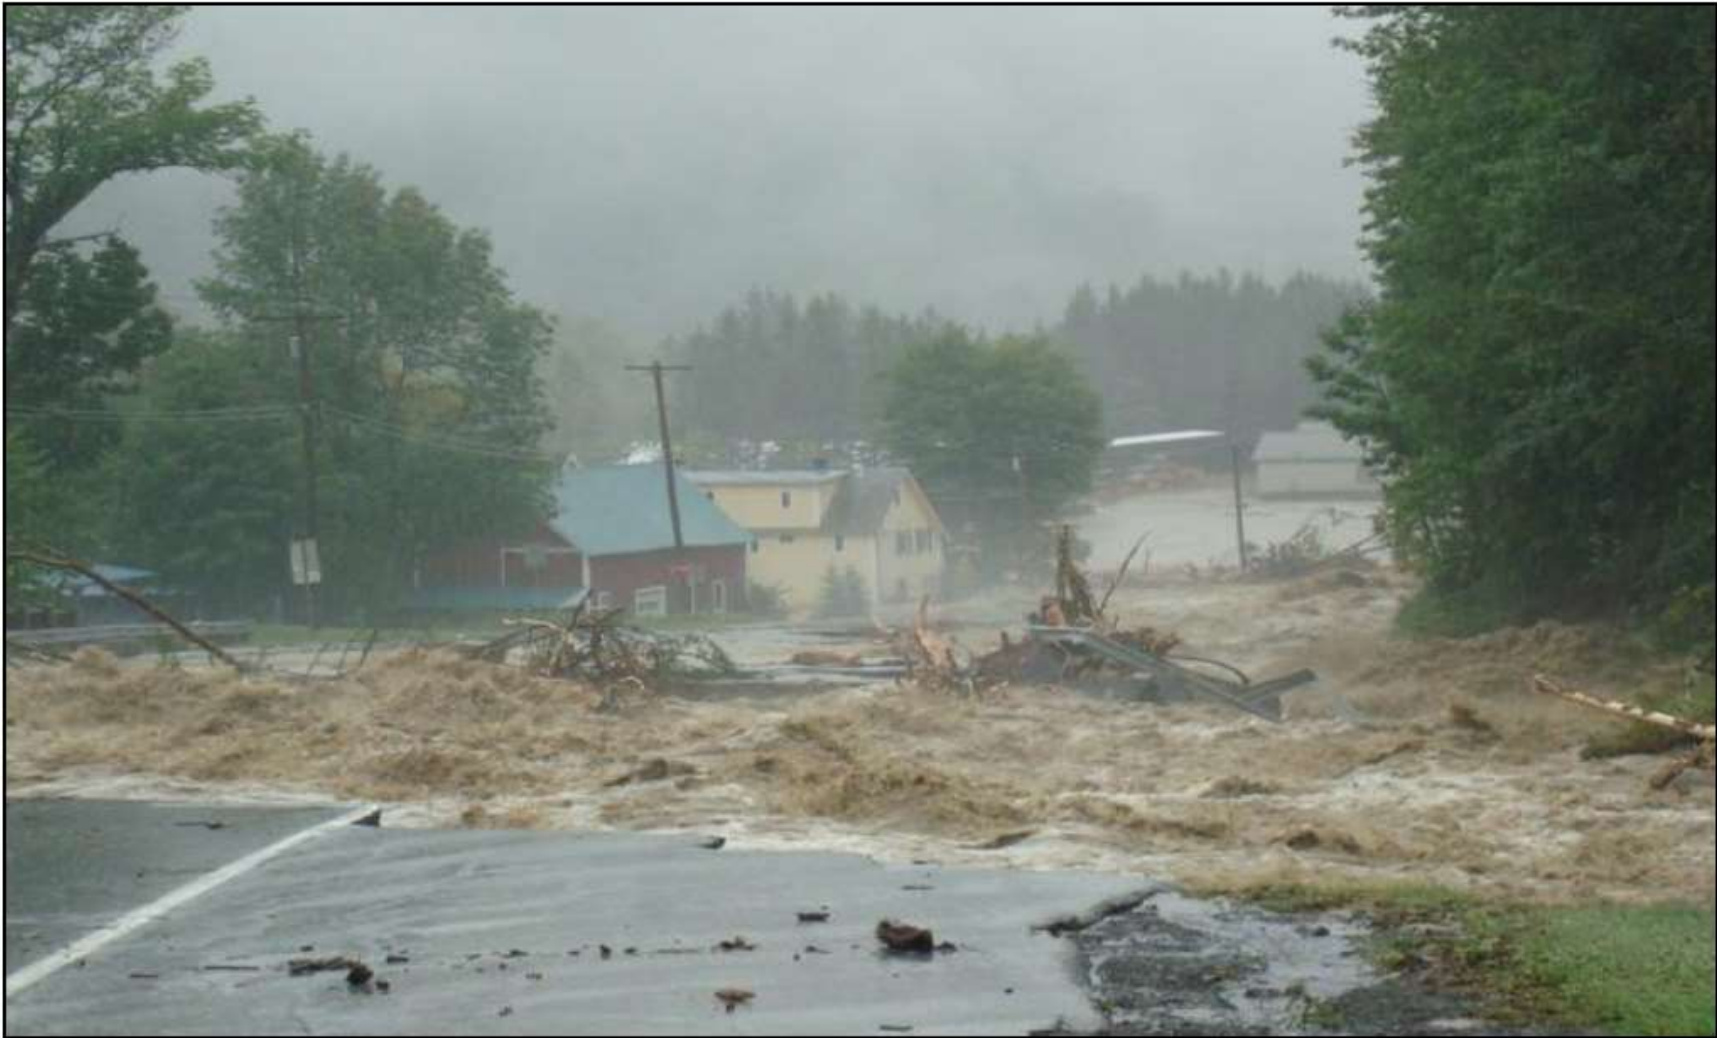
Brook (photo 3). Further downstream, Roaring Brook caused significant damage in the vicinity of the Route 4 corridor (photo 2).

Photo 2. Damages sustained to the Route 4 corridor further downstream on Roaring Brook during Tropical Storm Irene (August 28, 2011); (photo obtained from draft Town of Killington, Vermont, Local Hazard Mitigation Plan).

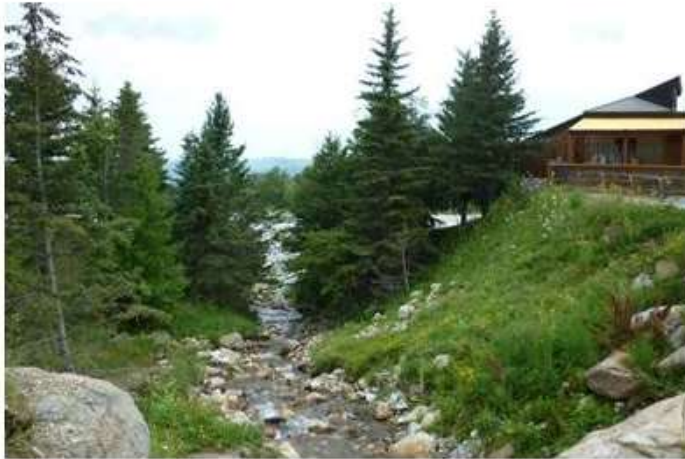
2. View downstream in restored reach of Roaring Branch adjacent to pub rebuilt farther to the east.

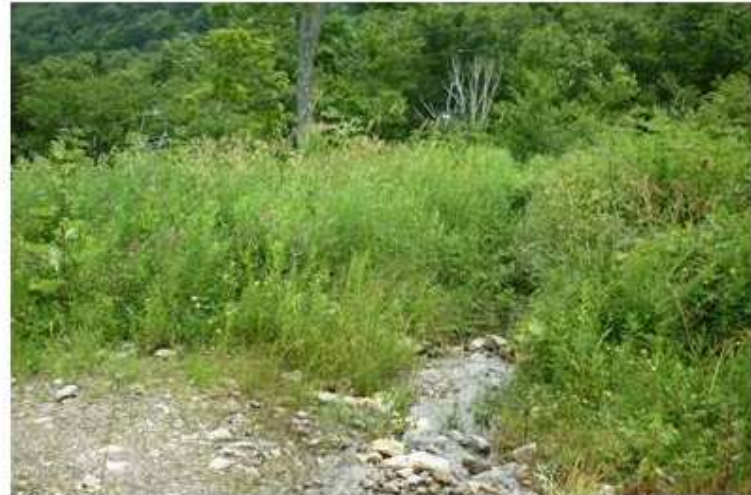
7. One of several water bars on maintenance road, draining to rock-lined detention areas, before discharging to Roaring Brook.

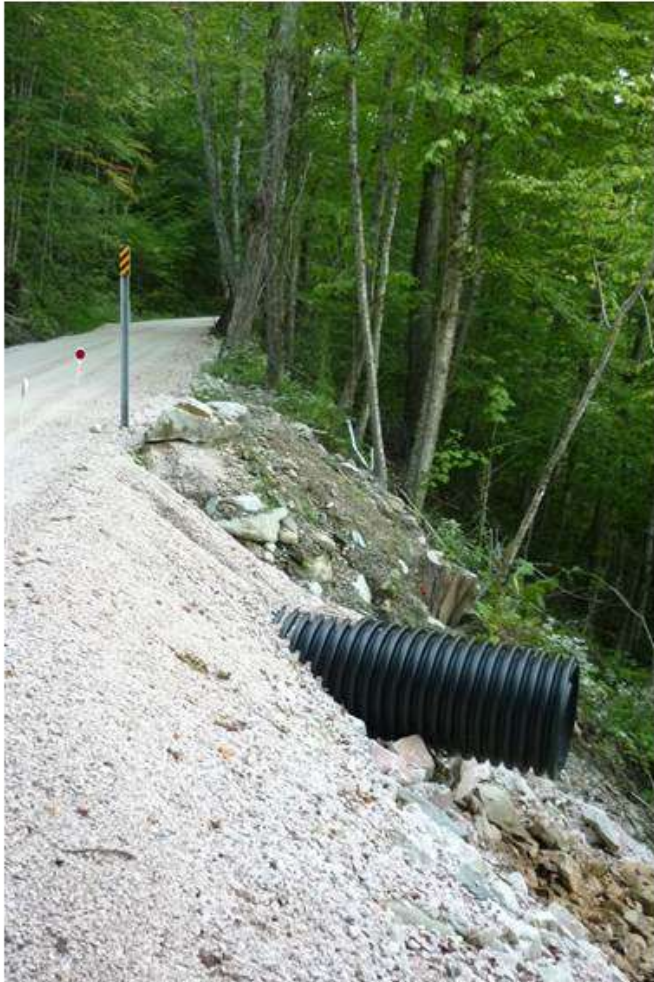
- Due to safety concerns, given the steep gradient and limited line of sight, one particular segment was replaced as a single-lane road with appropriate signage.

1. One-lane segment of CCC Road and stream crossing replaced after TS Irene on >25 % hillslopes through Northern Hardwood Seepage Forest.

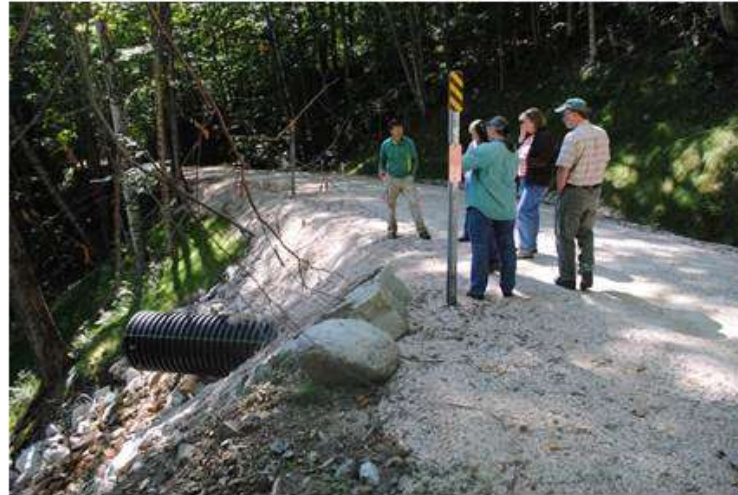
2. View downhill, same culvert site as photo 1.

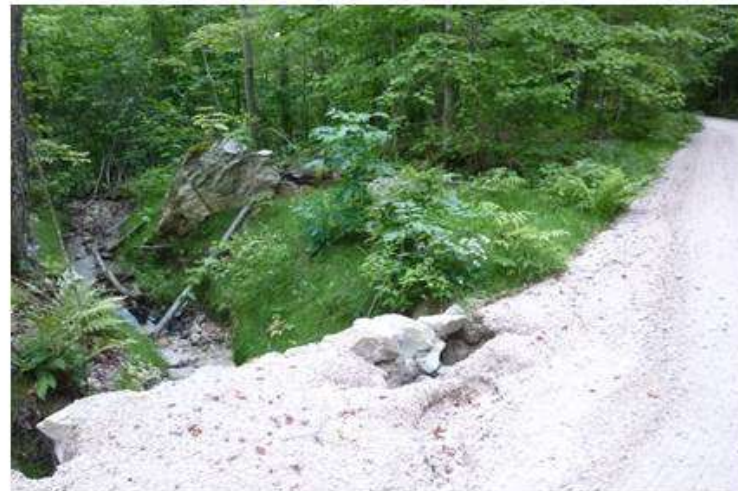
3. Erosion of road sediment from culvert header into tributary draining to Woodward Reservoir; site uphill from photo 1.

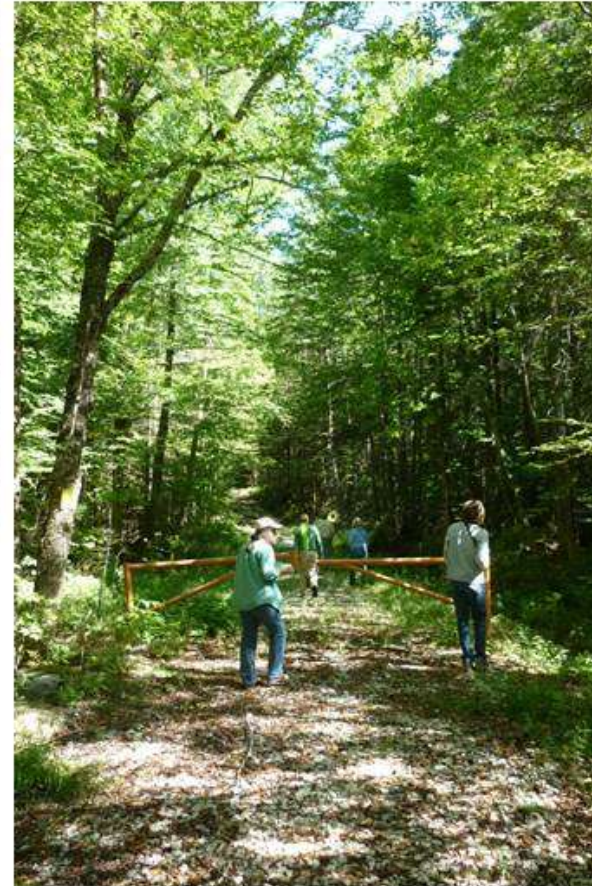
5. View into Plymsbury WMA from access area on north side Old Plymouth Road. Repaired following TS Irene.

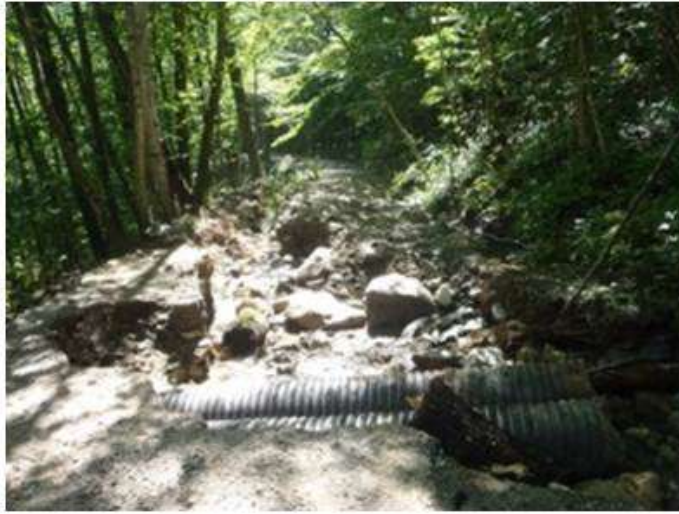
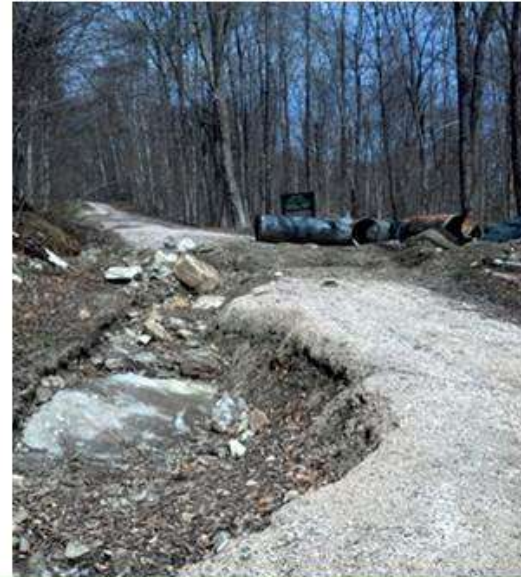
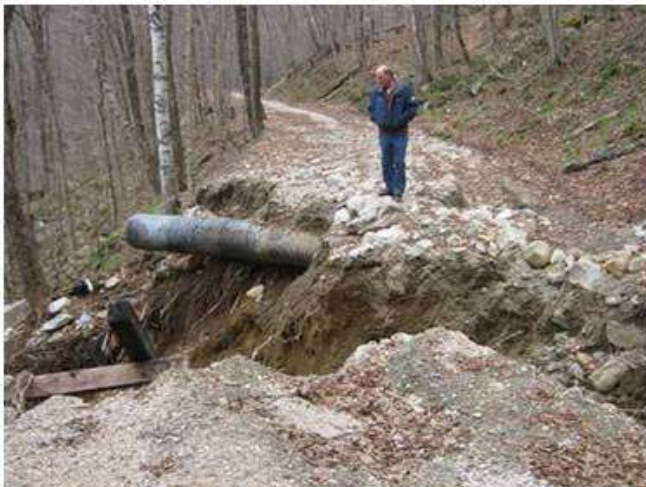
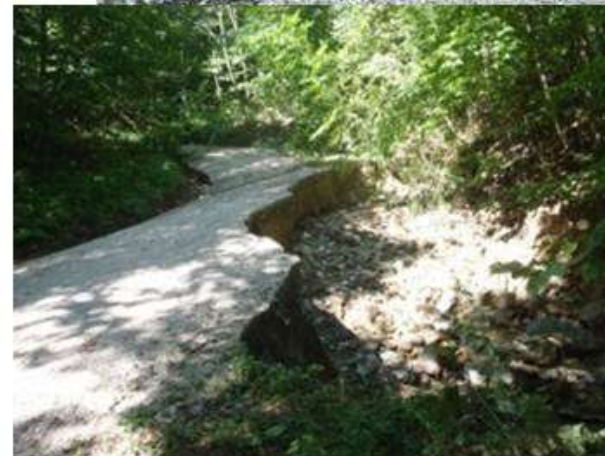
Damages to CCC Road, Tropical Storm Irene, Plymouth, VT

TS Irene resulted in extensive damages to the CCC Road and Old Plymouth Road. Segments of the CCC Road were washed out, timber cribbing was exposed and undermined, and culverts were displaced (see attached photos). The road was closed for 2 years, and reopened in the Spring of 2014. Road repairs were supported by FEMA funds, which reportedly amounted to approximately \$250,000.

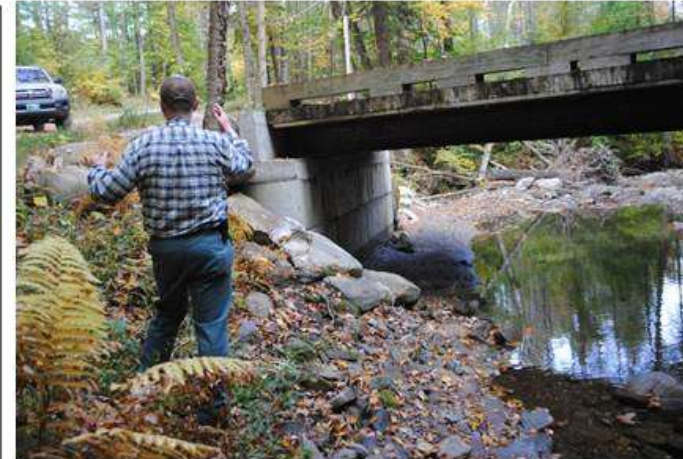
TS Irene caused damage to the forest highway bridge over Curtis Hollow Brook (Figure 5). The left-bank bridge abutment was replaced with design help from VDEC Facilities Engineering and funding from FEMA with local match provided by VFPR capital funds [1].

Abutment replaced after TS Irene

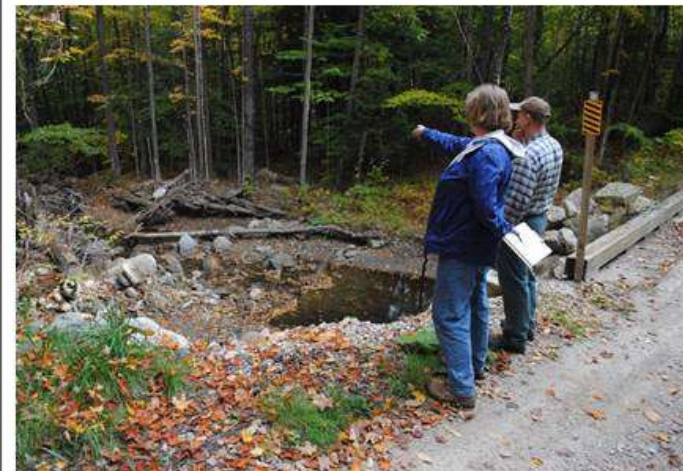
Opportunity to Disconnect Road Ditch

Figure 5. Location of stream crossing of Curtis Hollow Brook, and opportunity to disconnect road ditch drainage.

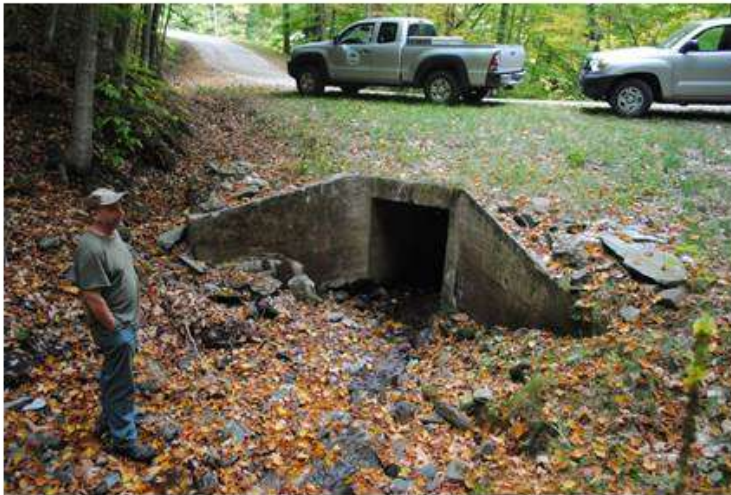
TS Irene resulted in damages to Quarry Road. Segments of the road were washed out. Debris plugged a box culvert, resulting in a small unnamed tributary overtopping and washing out the road. This stream drains a 250 acre watershed. This stream crossing and the road were constructed during the 1930s by the Civilian Conservation Corps [1].

1. View downstream to box culvert crossing of Quarry Road over unnamed tributary to Pinney Hollow Brook.

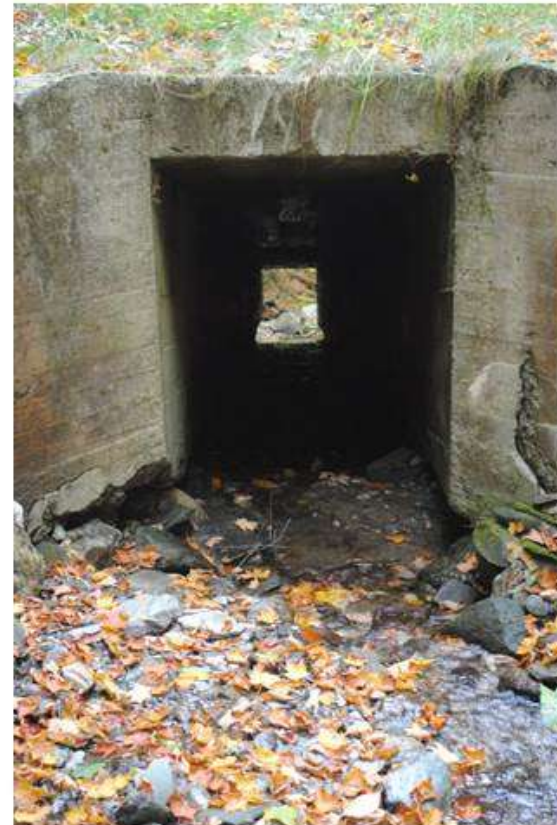
2. View downstream through box culvert.
