Appendix A

Site Visit Summaries

30 June 2015 FINAL DRAFT

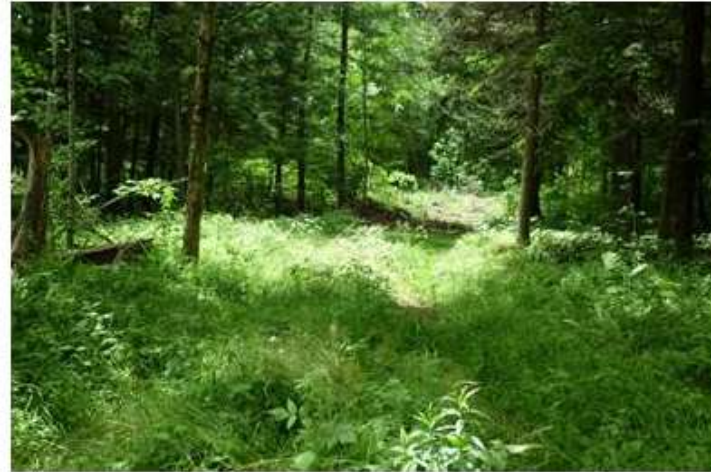
6. Road approach to stream crossing in photo 5.

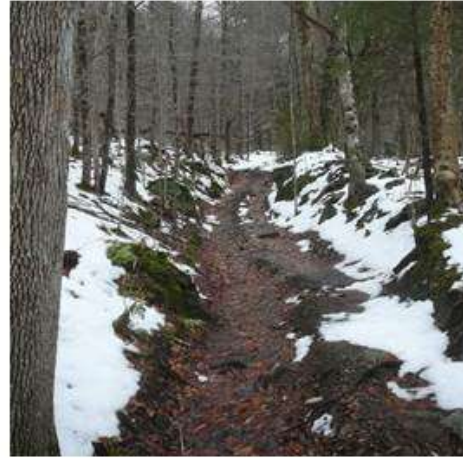
6. View uphill on narrow forest road that is channeling runoff; dugway banks are 5 ft high in sections.

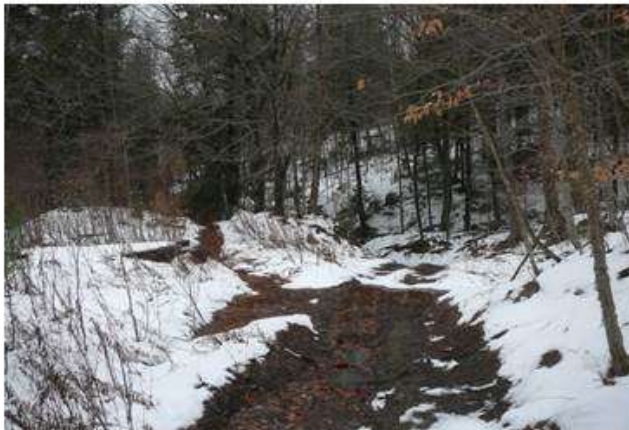
7. View downhill from photo 6; road drainage runs off to nearby stream

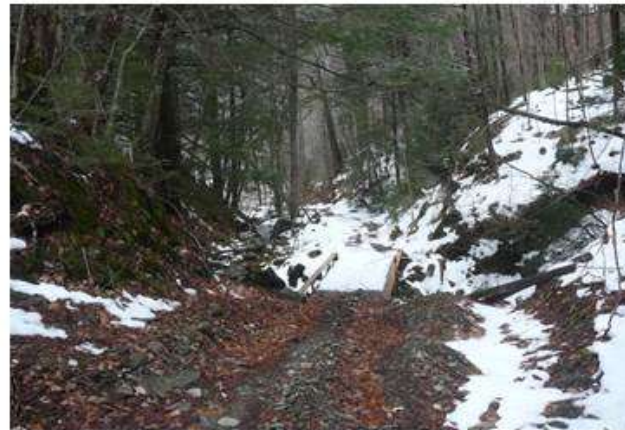
8. Road ditch directs runoff to the stream at the bridge crossing.
