Appendix A

Site Visit Summaries

30 June 2015 FINAL DRAFT

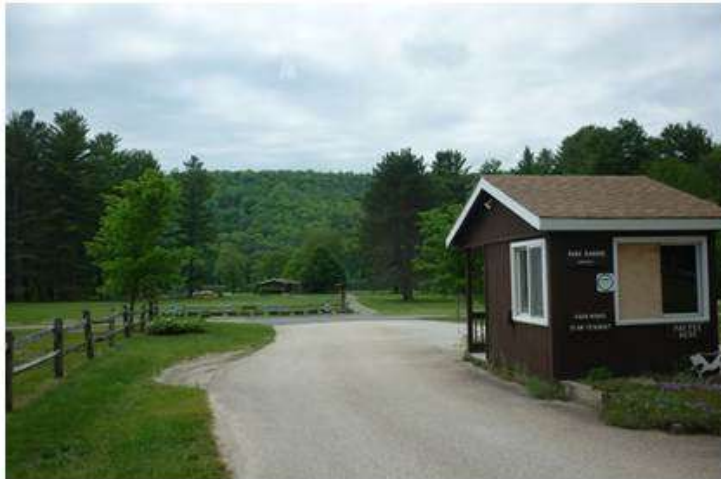
1. View to west from Scout Camp Rd, past Park entrance.

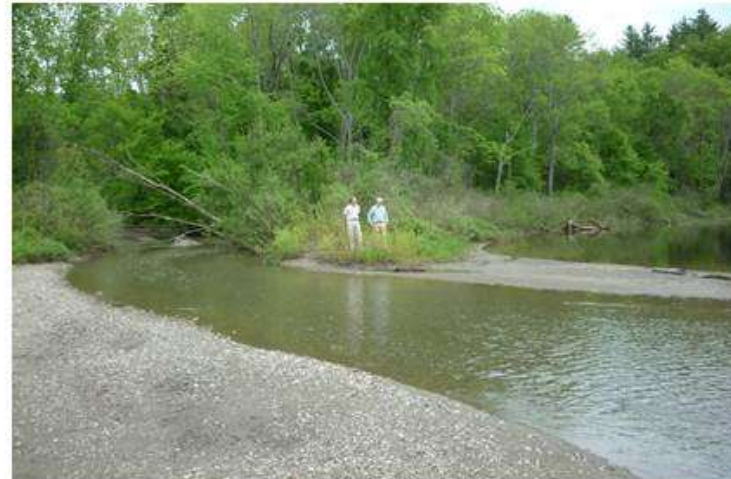
2. View of Buffalo Brook confluence with Echo Lake (delta)

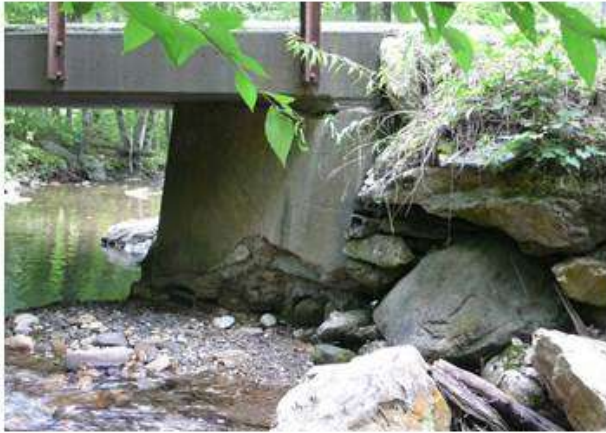
- Trees & debris jammed the Scout Camp Road bridge (photo 5). The bridge span is undersized (46% of the bankfull width) and has a sharp approach angle [5]. Buffalo Brook jumped its banks and breached a 1970s-era berm to flow between cabins and down the camp entry road (photos 3 & 4). Park roads were scoured up to 2 to 3 feet (Figure 3). Grass-turfed areas fared much better and had minimal erosion. The Park incurred approximately \$250,000 in damage; some expenses were reimbursed by FEMA, but the majority of expenses were paid for from the capital budget [7].

5. Right-bank abutment of Scout Camp Rd (2009)

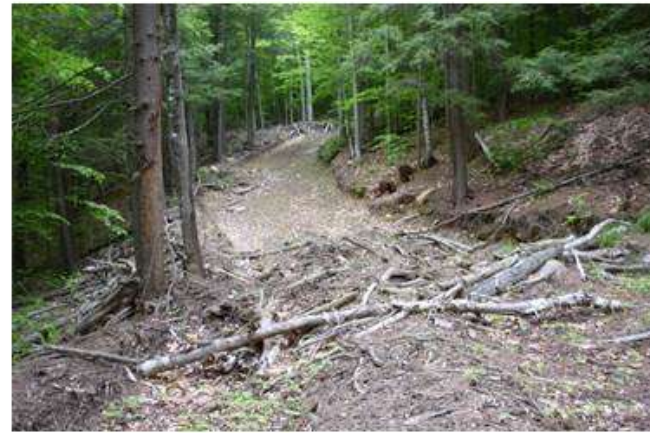
- Several segments of the new trail exceed 10% gradient and traverse very steep slopes (photos 6, 8).

6. View uphill from trail junction to C2; 25% road gradient.

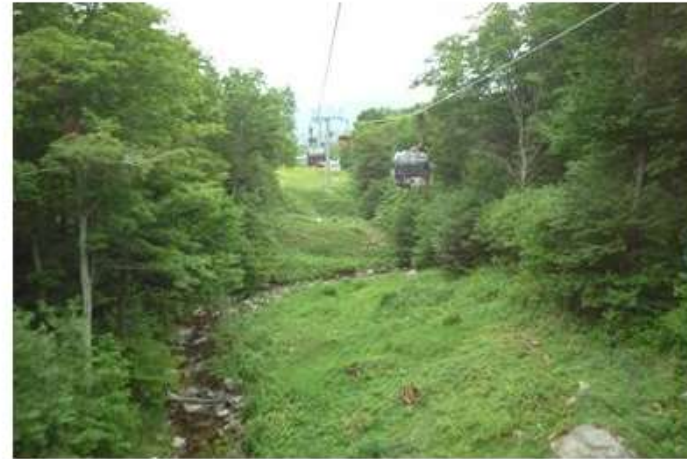
Brook (photo 3). Further downstream, Roaring Brook caused significant damage in the vicinity of the Route 4 corridor (photo 2).

3. View of Roaring Branch from Gondola lift to Peak Lodge.

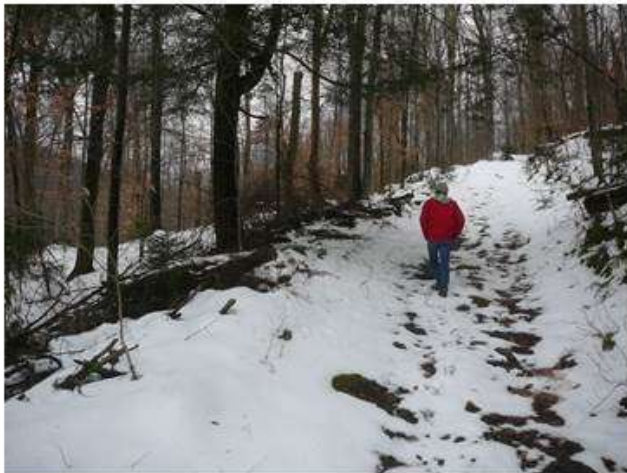
3. Steep-gradient road (10 to 40%), with occasional broad-based dips; dugway segment channels water downhill.

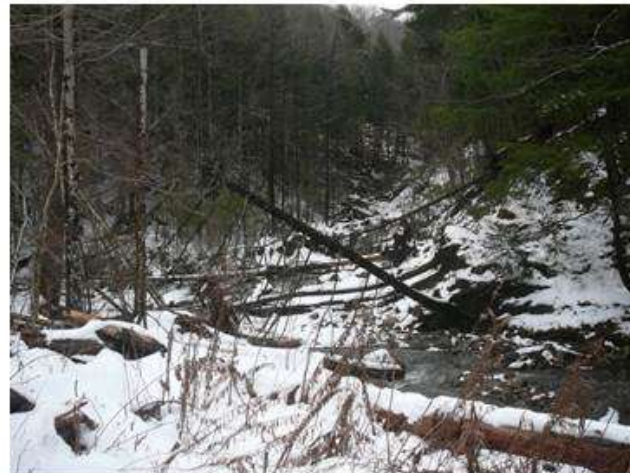
4. View upstream in tributary to Stony Brook exhibiting significant widening, incision.
